NDI No. Pa. - 231
HIGH POINT LAKE

PHASE I INSPECTION REPORT
NATIONAL DAM INSPECTION PROGRAM

High Point Lake Dam

13 October 1978

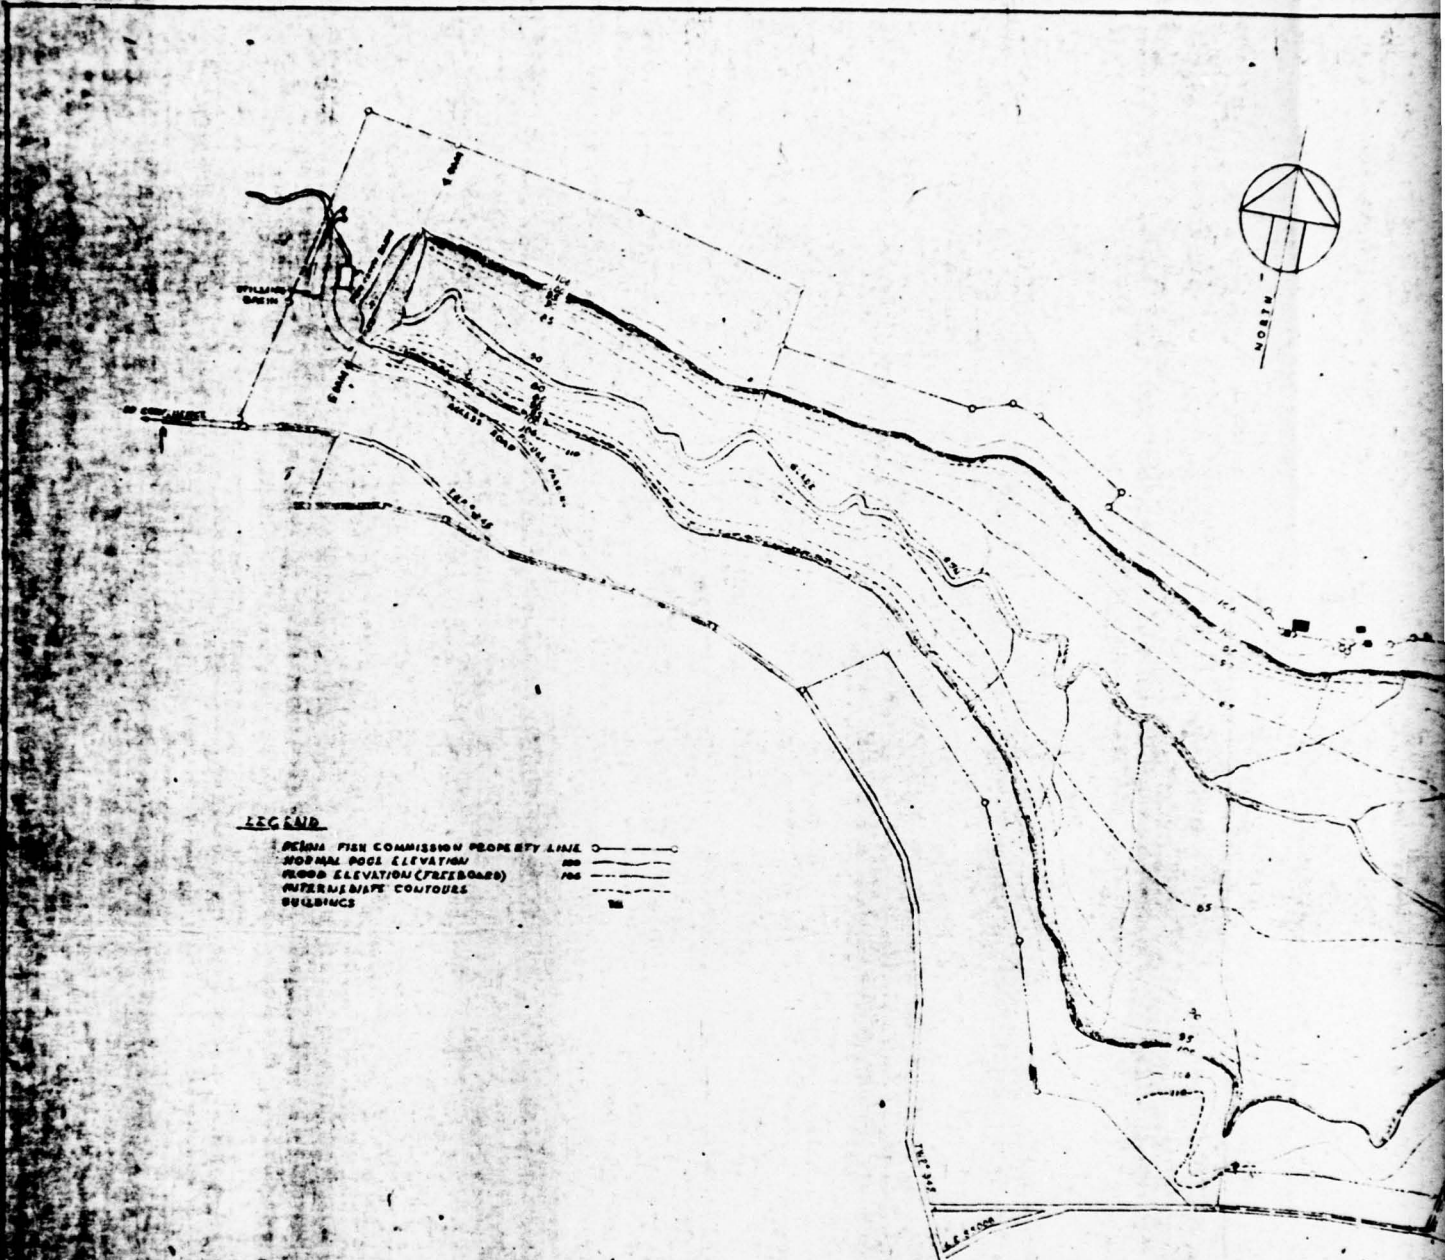
FIGURE 1

Some seepage was observed in the area just to the right of the right spillway sidewall. It is probable that the seepage is passing through or atop the original ground surface since there is little fill in the area (see Figure 1). In any case, the seepage is not considered serious at this time (seepage flow could not be measured) although small erosion gullies are forming.

a. Embankment. Based on visual observations, the embankment appeared to be in good condition. Some seepage (saturated zones-flows could not be measured) was noted to the right of the spillway sidewall in the area shown on Figure 1. Small erosion gullies had developed in the area in what appears to be natural ground. The situation, in its present state, is not considered serious.

Erosion gullies to the right of the spillway (see Figure 1). May be springs in original ground but apparently they are now being fed by the reservoir pool since the spillway excavation would have cut off any source on the left abutment.
